TECHNICAL NOTE

Filing Code 7420
Date Issued 7/15/72

FLOAT VALVE TANK

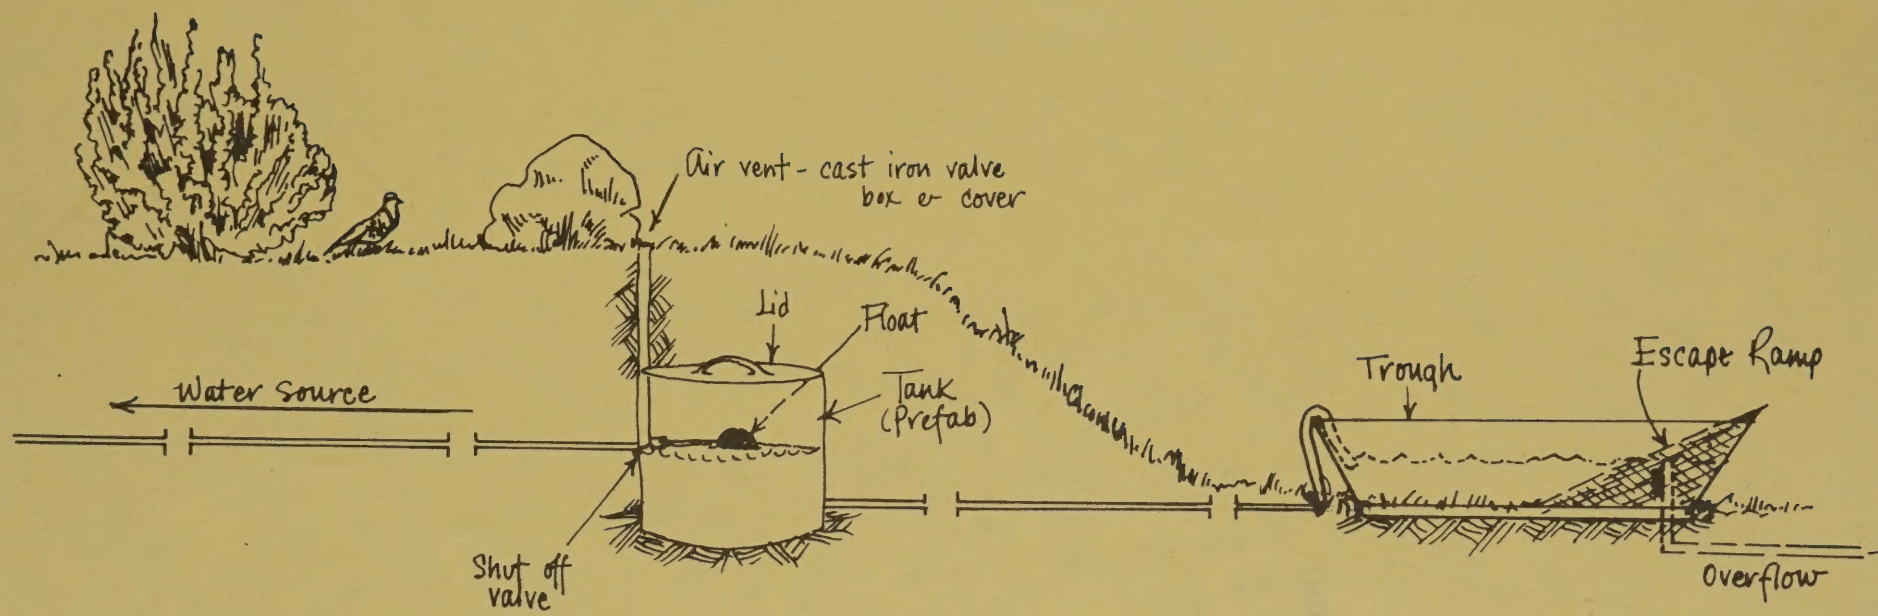
Float Valve Tank

Numerous questions have been raised by field personnel regarding problems concerning float valves located in watering troughs. Mr. Dick Holland of the Carson City District Office, Nevada, has installed and tried out a buried float valve tank for the past two years. It has worked out satisfactorily and with no maintenance problems in the short time it has been tried.
